Kevin's Corner Coal Mine Project

Environmental Impact Statement

Contaminated Land Preliminary Site Investigation

22 FEBRUARY 2011

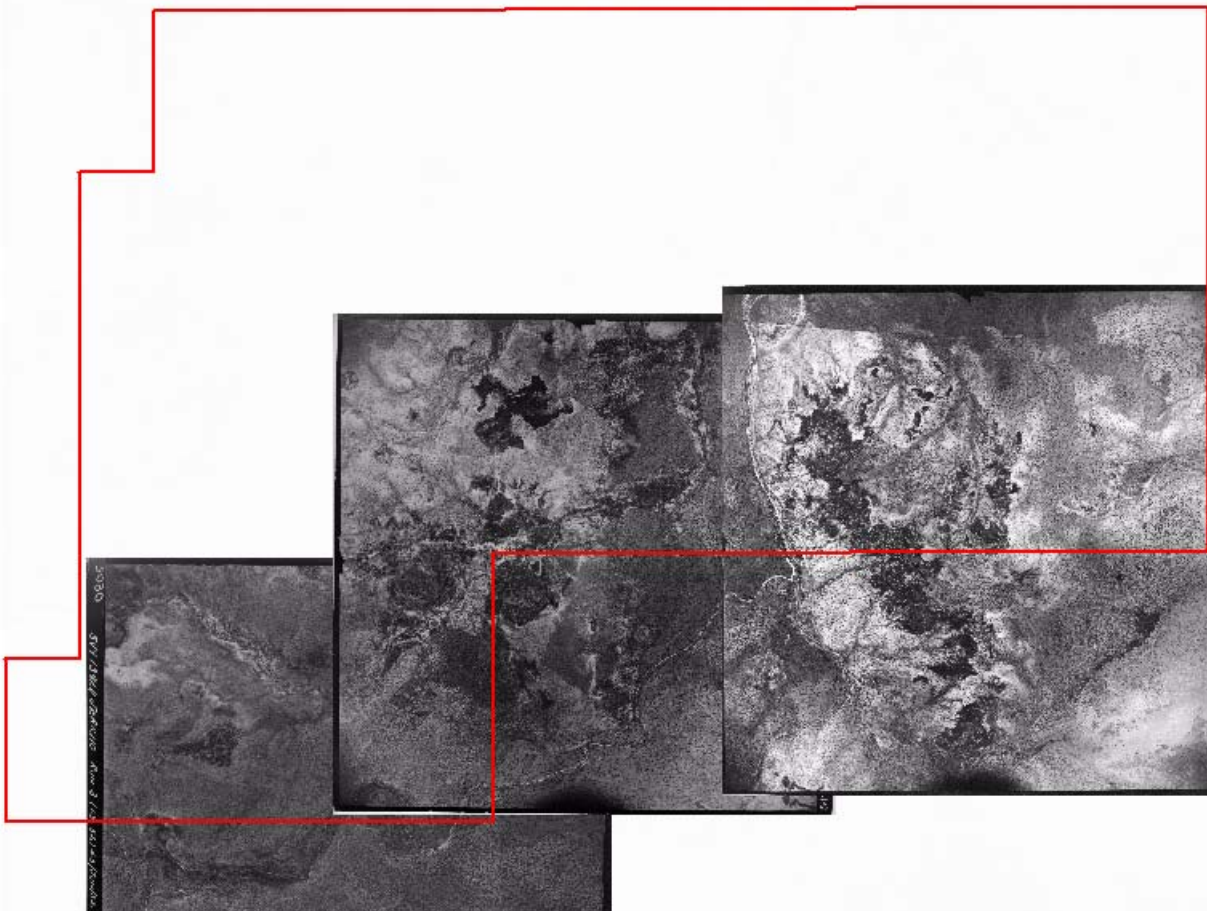
Year	Site Details
1952

<p>Site is undeveloped, some tracks and fences are visible.</p>

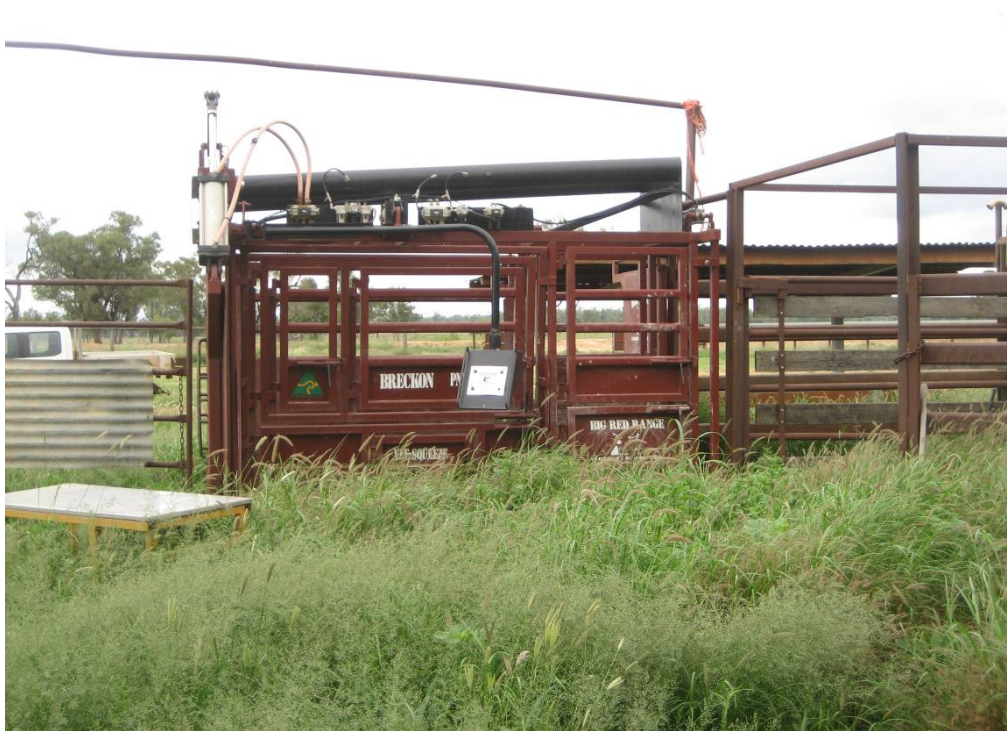
Plate-1 Wendouree stockyard – pneumatic crush

The stockyard located on Wendouree was identified from aerial photographs as being constructed between 1969 and 1980. The stockyard was well maintained and contained a series of holding yards and runs. A pneumatic crush (Plate 1) was located within the yard. No evidence of a dip was noted, however one bottle of “Sumifly” (a synthetic pyrethroid), used to treat buffalo fly was identified (Plate 2). The homestead owner confirmed minor usage to treat stock. This was generally applied as a backline spray. No other evidence of pesticides was noted at the stockyard during the visit.

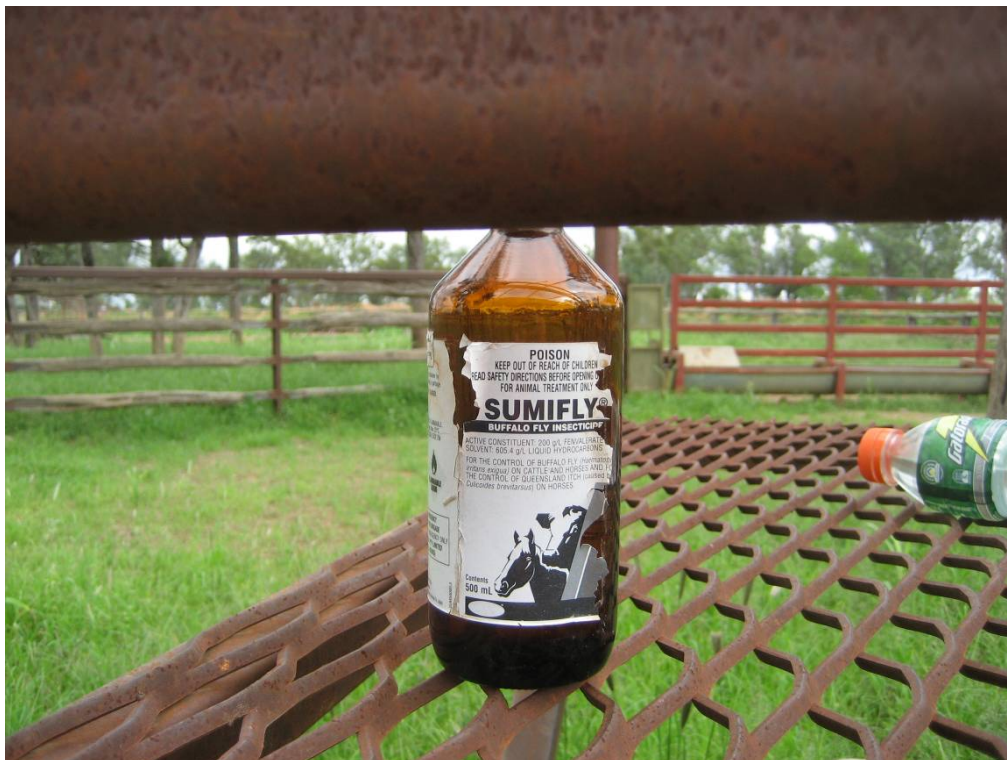
Plate-2 Wendouree stockyard - "Sumifly" insecticide

URS was informed by the current leaseholders across the Project site did not generally use pesticides, tickicides, or other farm related chemicals. Minor use of a pesticide to treat Buffalo Fly (Sumifly) was noted at the Wendouree stockyard, and confirmed by the leaseholder. The active ingredient of this is Fenvalerate 200 g/L, liquid hydrocarbons 605.4 g/L as solvent.

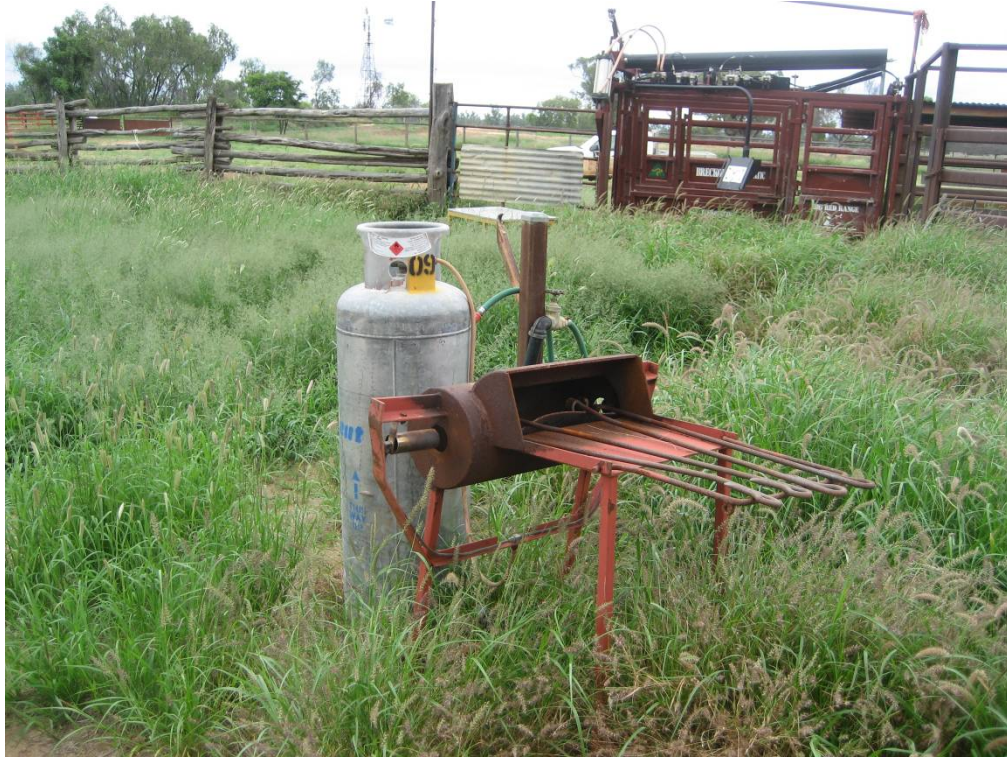
**Plate-3** Wendouree stockyard – gas fired branding pit

A gas fired branding pit was identified within the stockyard. The gas canister appeared to be in good condition (Plate 3).

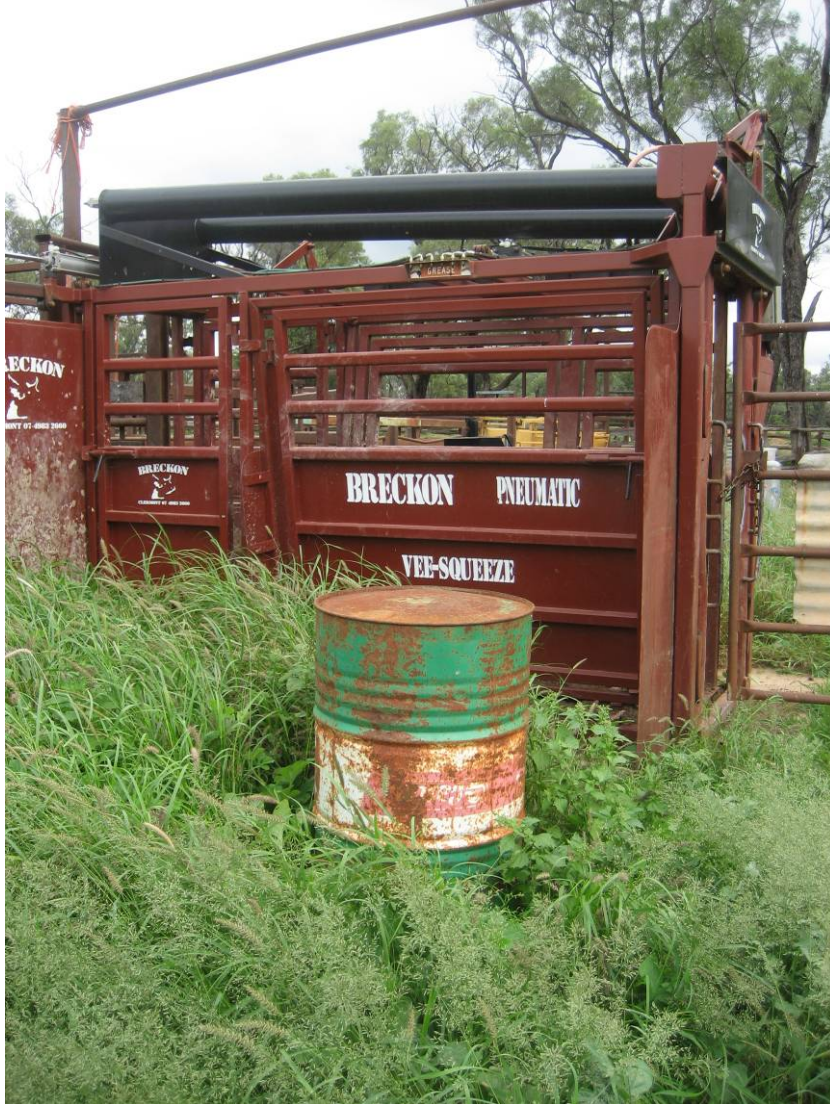
**Plate-4**      **Wendouree stockyard – discarded drum**

Some discarded drums were noted adjacent to the pneumatic crush, the 205 L drum was approximately half-full, and the container, although rusted appeared to be in sound condition (Plate 4). No evidence of soil staining was noted surrounding the drum.

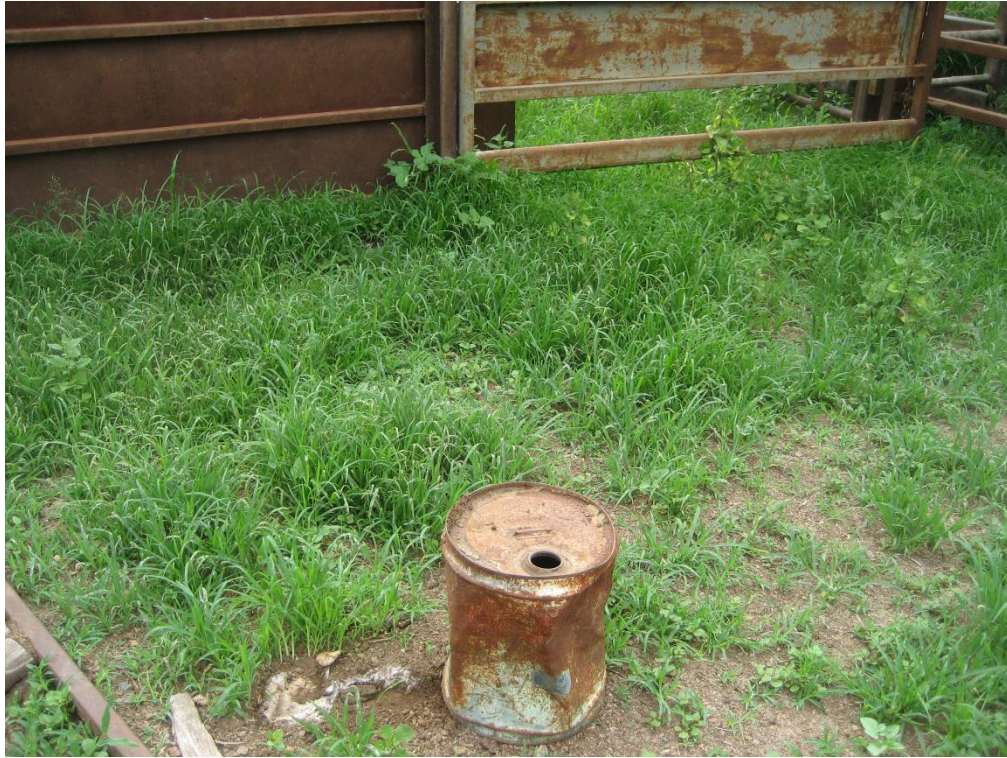
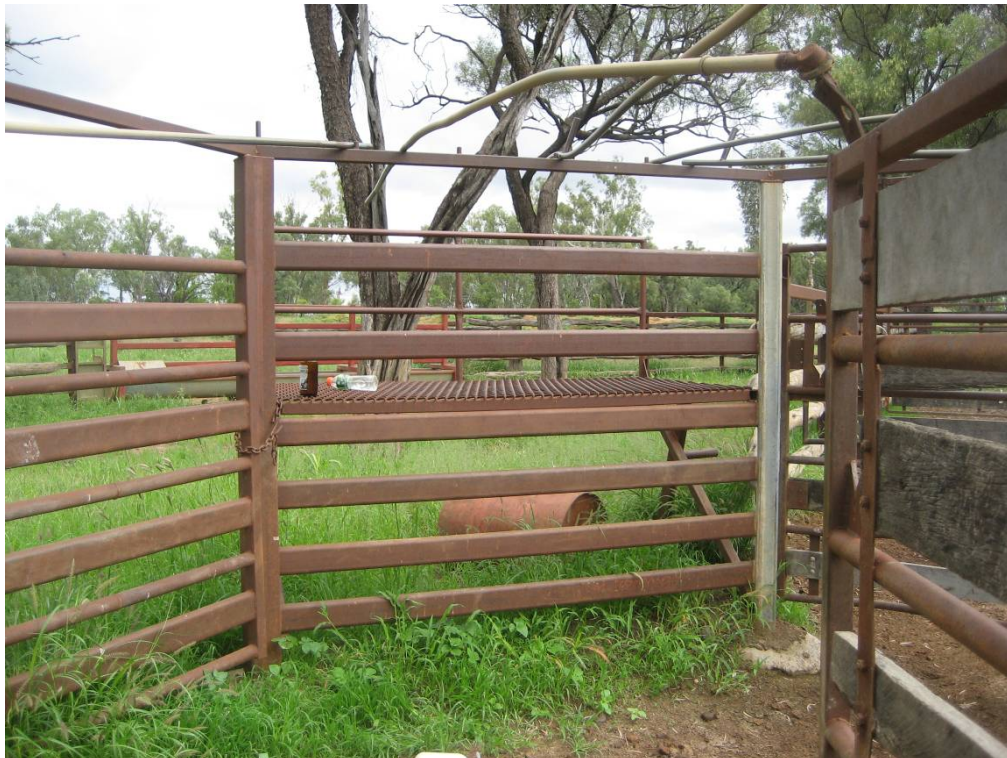
Additional discarded drums were noted within the stockyard area. The drums were empty and the containers were too rusted to establish its prior contents. Plate 5 and Plate 6 illustrate these; however no evidence of staining was noted.

**Plate-5** Wendouree stockyard – discarded drum

**Plate-6** Wendouree stockyard – discarded drum

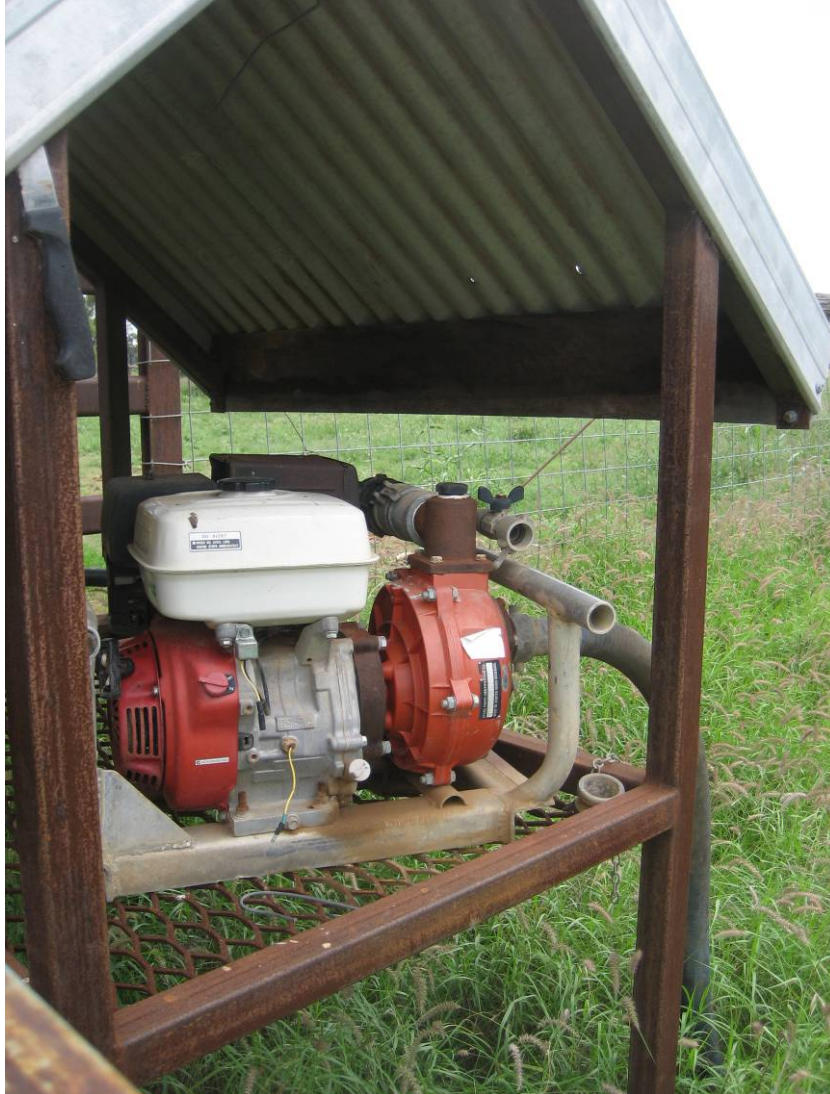
**Plate-7**      **Wendouree stockyard – water pump**

A petrol driven Honda pump was apparently used to transfer water from the adjacent dam to the stockyard troughs. The pump is in good condition, and well maintained and housed (Plate 7).

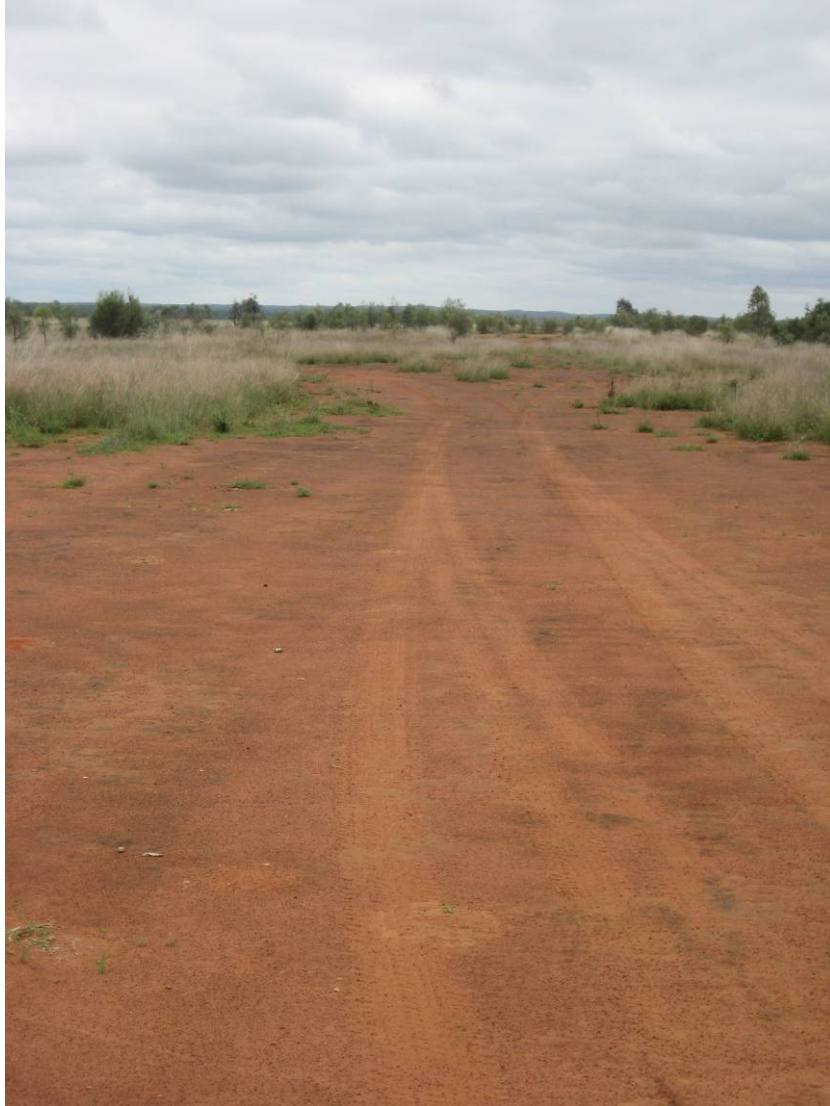
**Plate-8**      **Wendouree airfield**

The Wendouree airfield was identified from historical aerial photography as being constructed between 1969 and 1980. The airfield was reportedly built for use aircraft associated with exploration works. At the time of the site visit, the airfield was overgrown with vegetation; however, the improved gravel surface was evident. No fuel storage or buildings were identified in this location (see Plate 8).

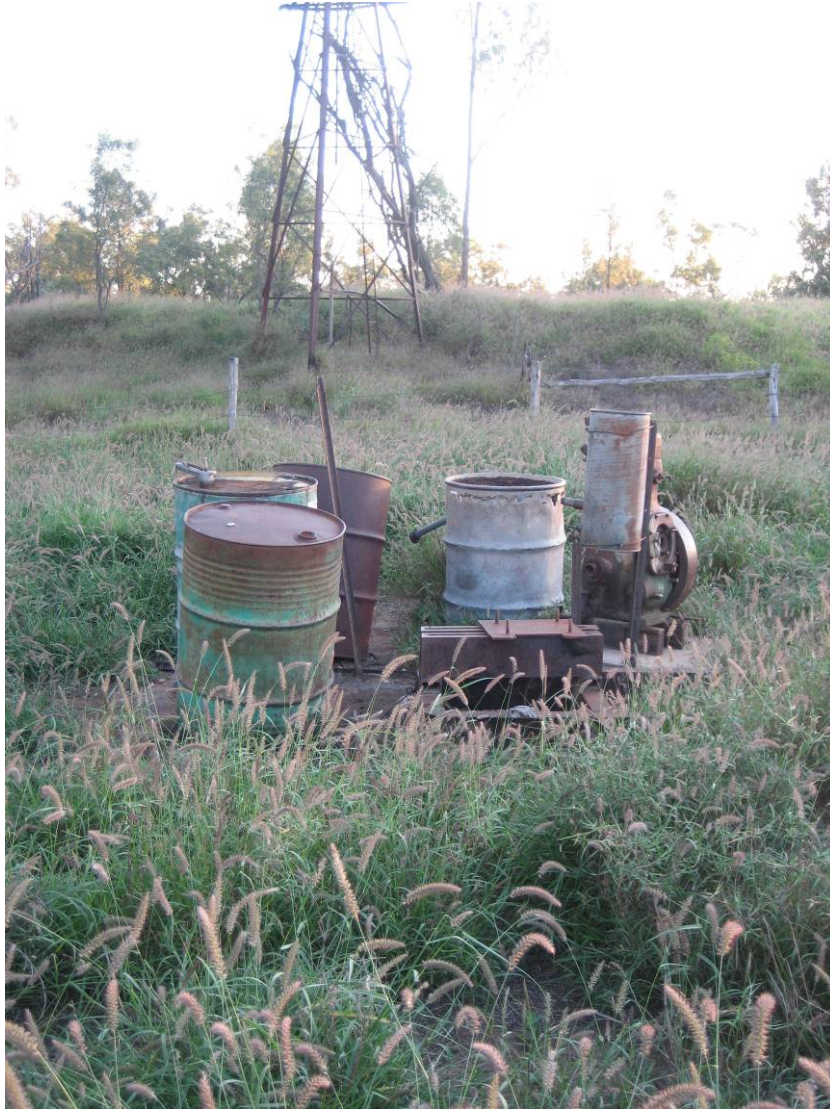
**Plate-9**      **Wallaroo bore – drum storage**

The Wallaroo Bore (ID 3 on Figure 3) was visited after discussion with the McKeerings. The Wallaroo bore was currently disused, however numerous drums of fuel/waste oil were noted at this site (Plate 9). Some evidence of minor staining was visible (Plate 10). Underneath the windmill, a discarded oil can was noted and an area of staining was visible, and it was considered likely that it had drained/leaked from the windmill infrastructure above (see Plate 11).

URS recommends that prior to disturbance/excavation; soils and possibly groundwater in areas of visual contamination are investigated by a suitably qualified person (as per Section 381 of the EP Act). Additionally, should soil staining or stock dip structures be encountered during any earthworks, work should be stopped in the area until assessment by a suitably qualified person has been undertaken. This investigation/assessment will assist to characterise the potential contamination and ascertain the extent and evaluate any potential risk to site users or the environment. Characterisation of the potentially impacted soils will allow for assessment of future management and disposal options, in accordance with the Department of Environment and Resource Management (DERM) *"Draft Guidelines for the Assessment and Management of Contaminated Land in Queensland"* (1998).

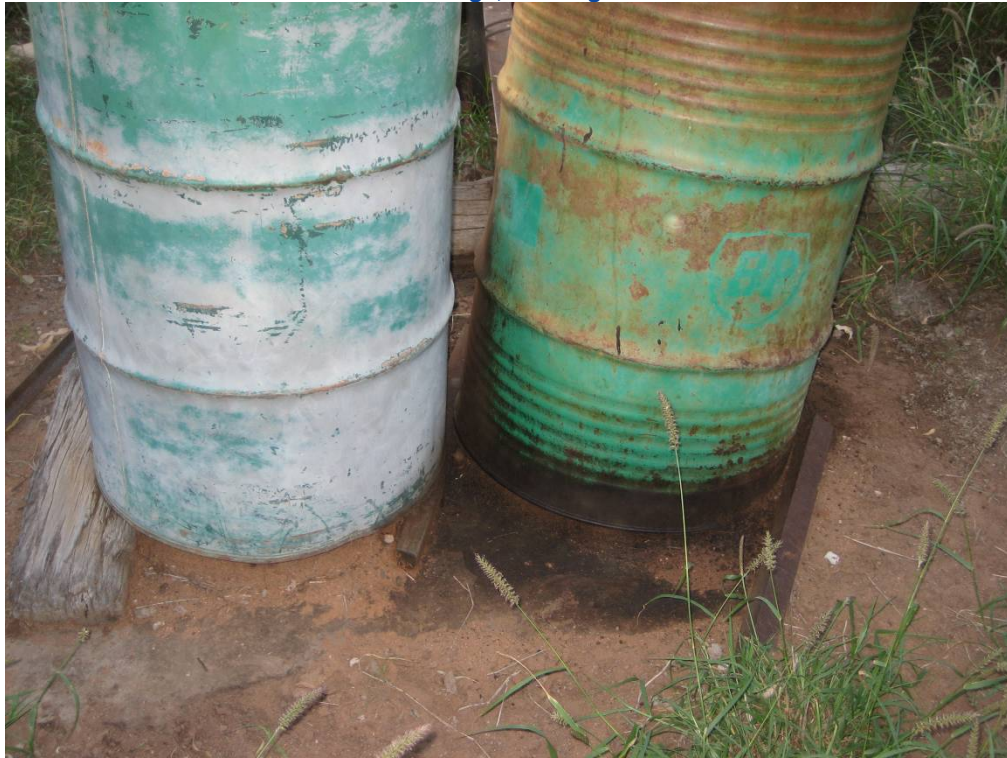
**Plate-10** Wallaroo bore – drum storage, staining

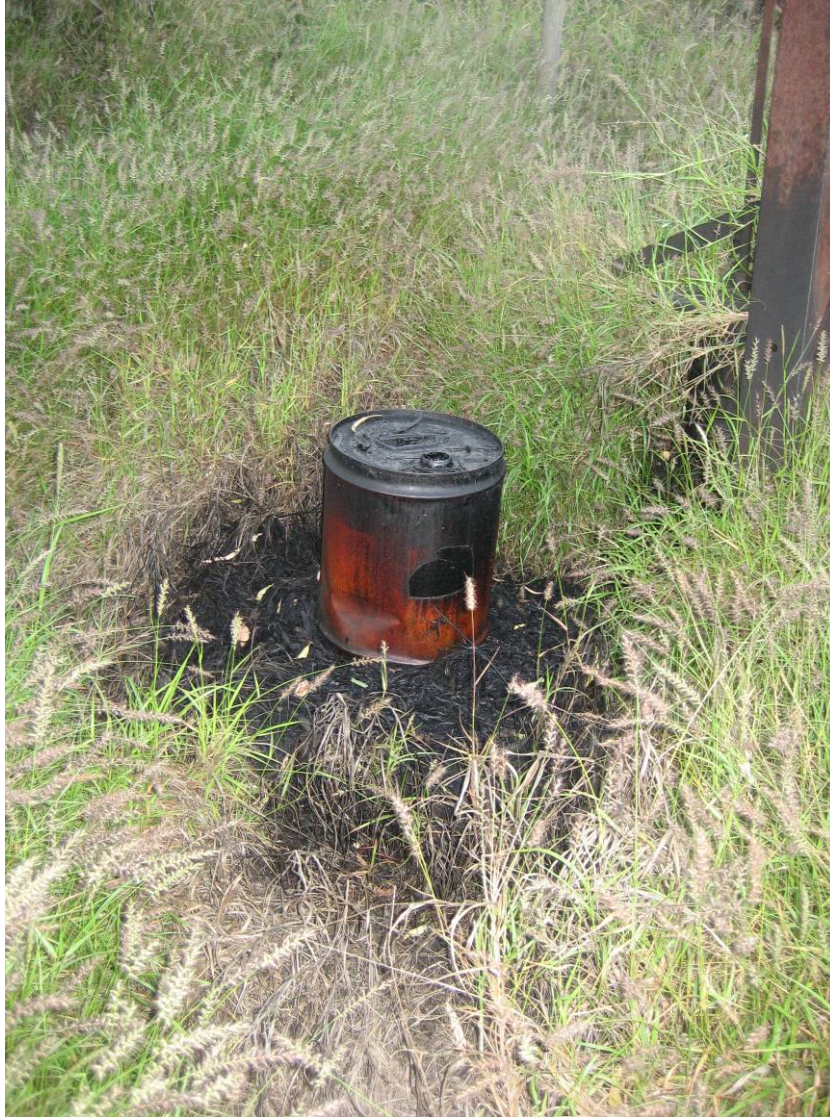
**Plate-11** Wallaroo bore – waste oil staining

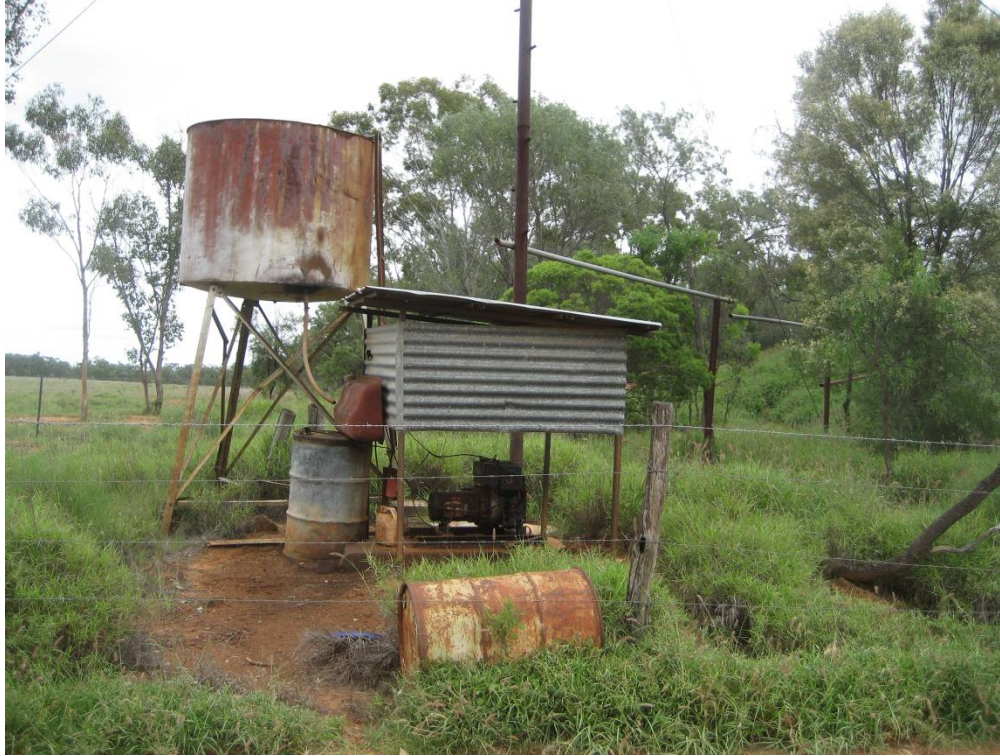
Middle Creek was the site of a 'turkey's nest' dam, with associated pump infrastructure (see Plate 12). The aboveground storage tank (estimated to be 500 L, with a hose leading to the location of the pump) was empty at the time of the visit and fuel was being pumped from the 205 L drum adjacent to the shed. Minor staining was visible on the ground and cement pad beneath the pump (Plate 13). Discarded rusted drums were also identified adjacent to this site (Plate 14).

**Plate-12** Middle Creek - water pump and fuel storage

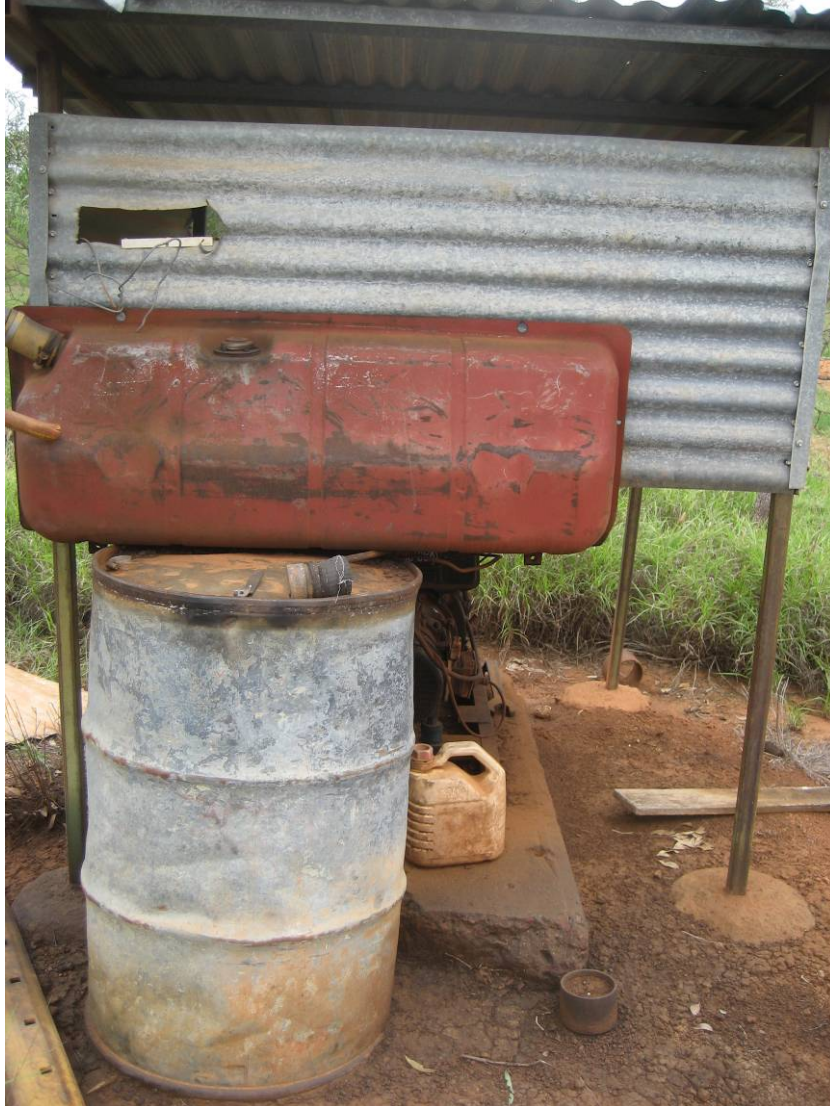
**Plate-13** Middle Creek – fuel storage and minor staining

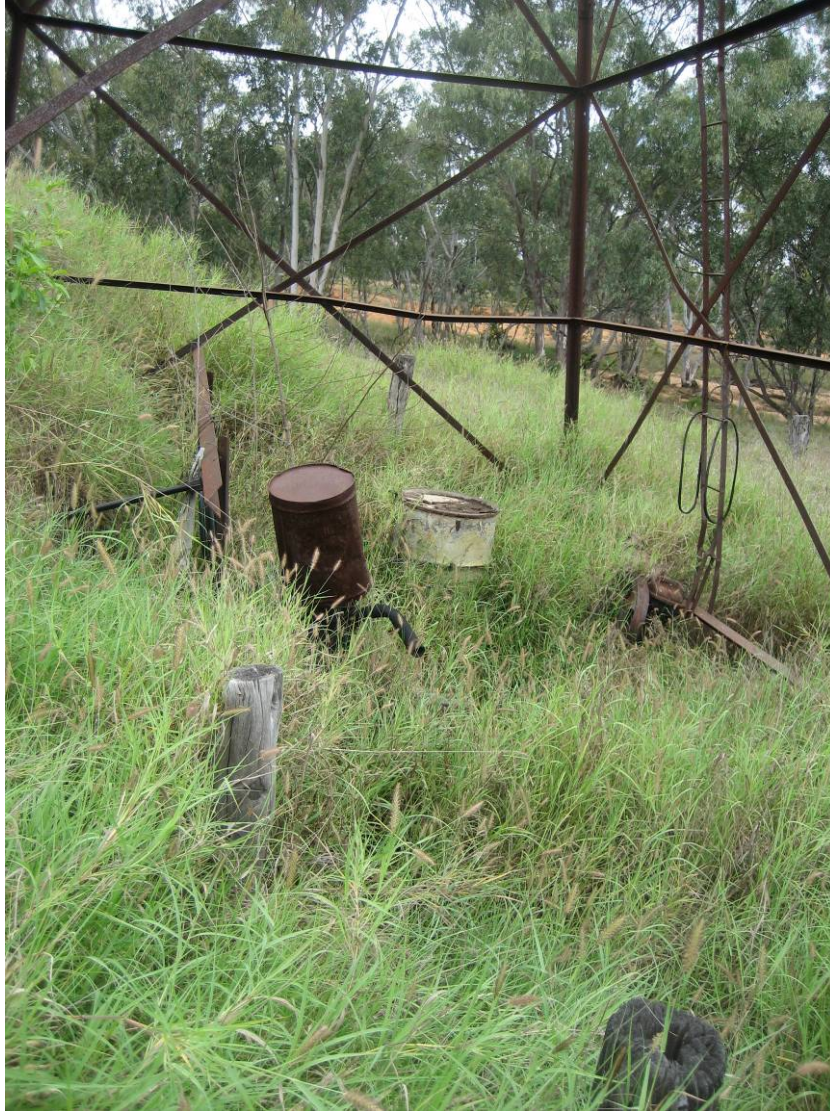
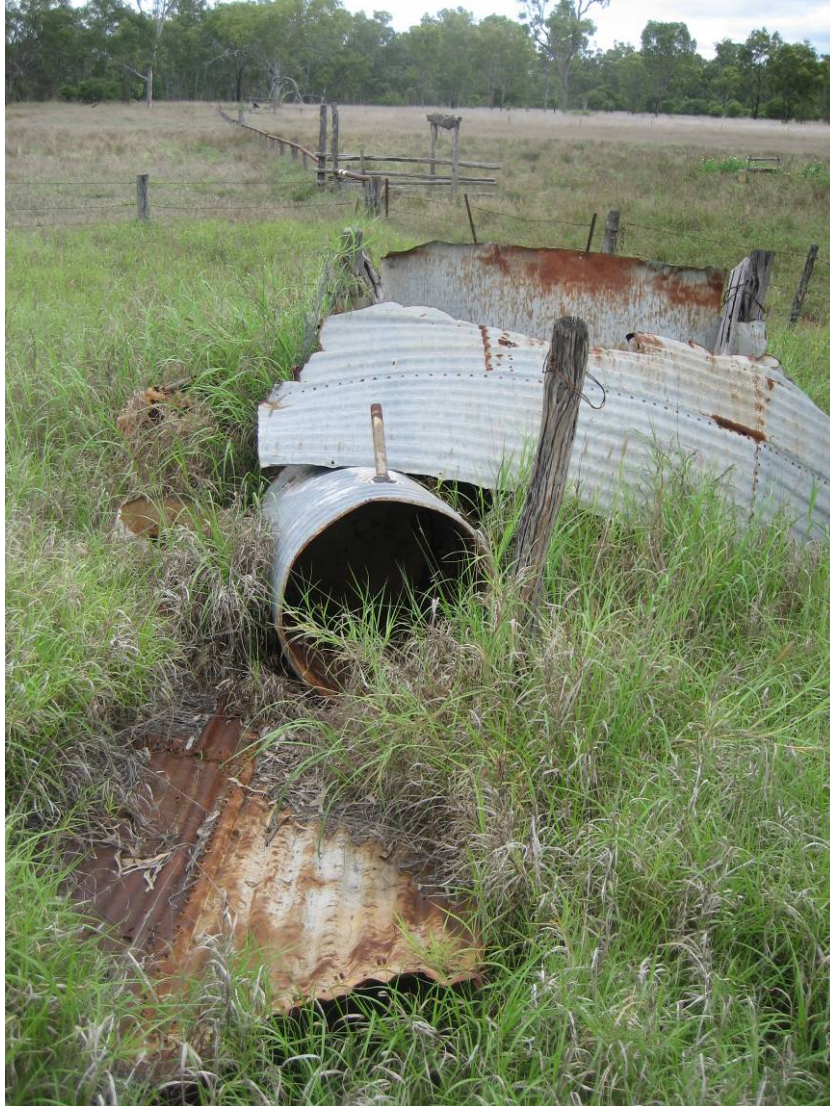
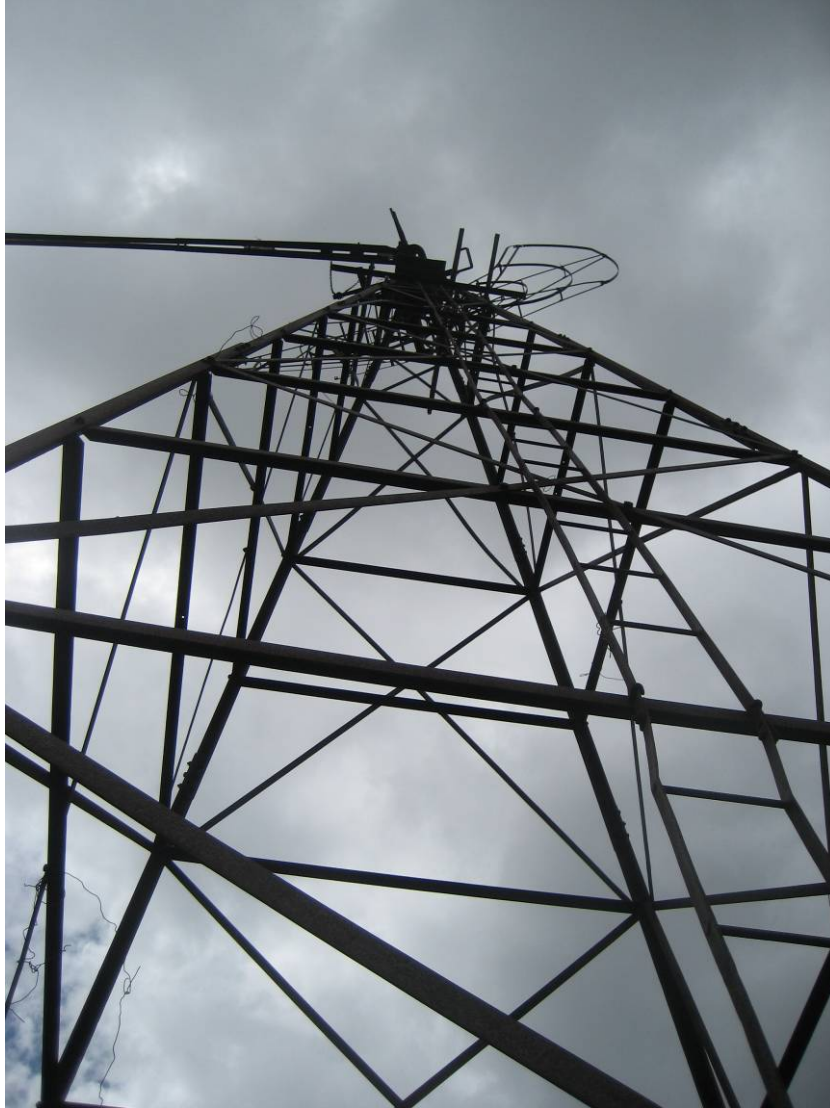
Greentree Creek was the site of a defunct windmill. At the time of the inspection it was noted that, fuel and oil storage containers had been discarded on the ground (Plates 15 through 17). Evidence of minor staining around these containers was noted.

**Plate-15**      **Greentree Creek – Discarded fuel and oil storage**

**Plate-16**      **Greentree Creek – Defunct water tank**

**Plate-17**      **Greentree Creek – Old Windmill**

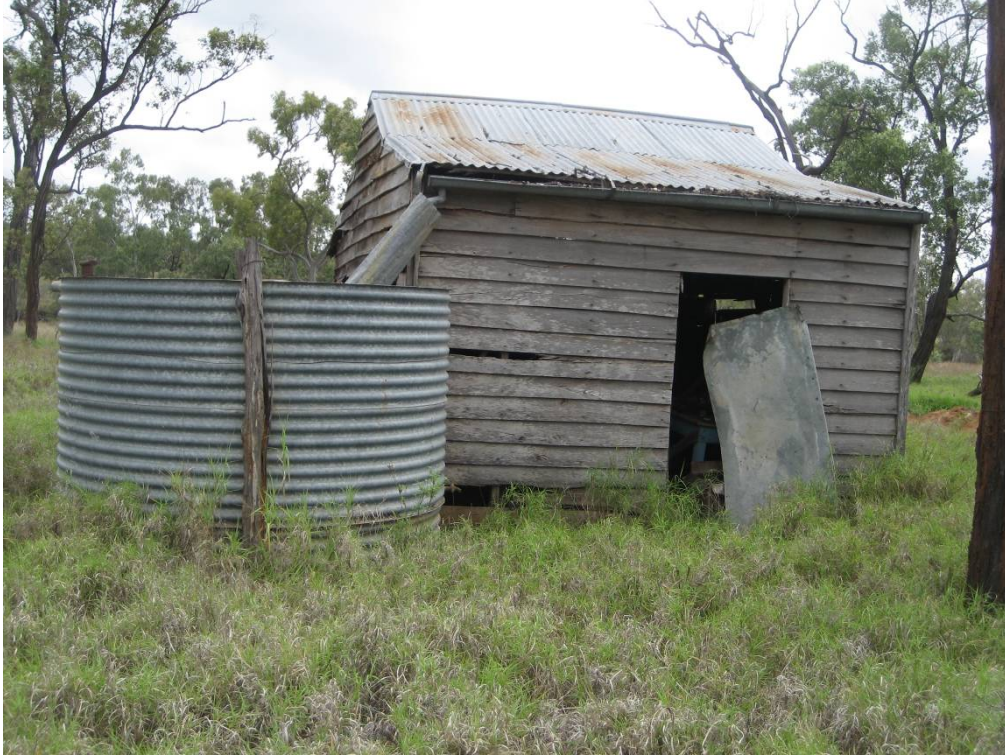
**Plate-18**      **Cudmore Hut**

An abandoned farmer's hut was located on the border of the Forrester and Cudmore Resources Reserve boundary. The small hut contained personal belongings although it appeared to have been abandoned many years ago. There was some metallic debris surrounding the hut, which may have been a defunct water tank). (Plate 18) and Plate 19)

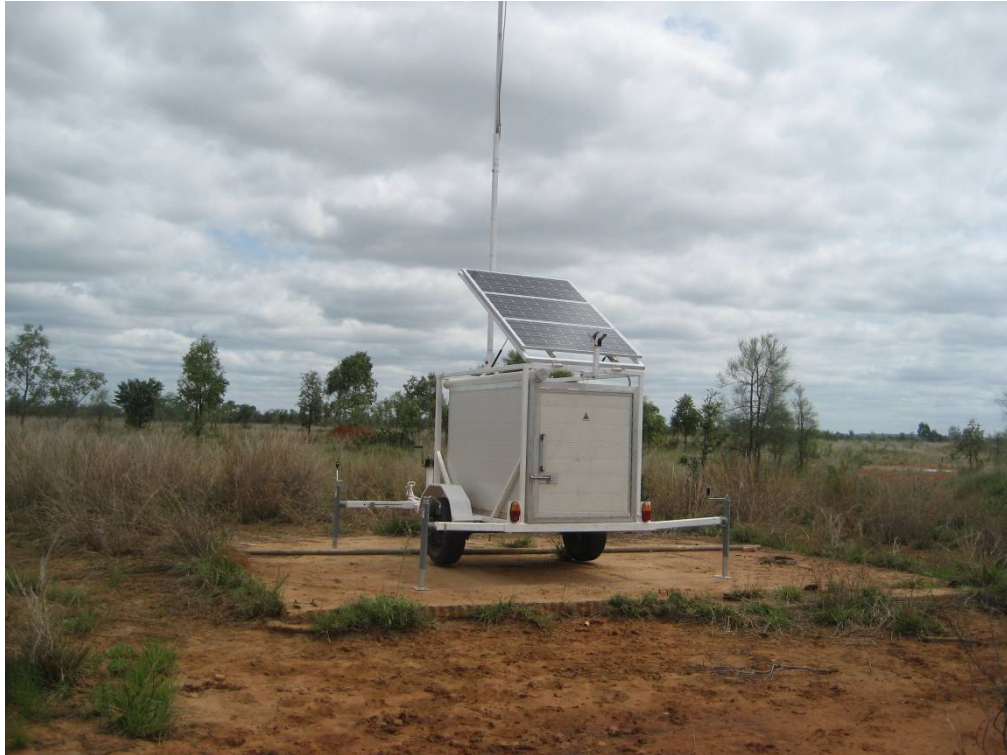
**Plate-20**      **Old Coreshed Site - presently used to site a mobile radio repeater station**

A concrete slab was located east of the Wendouree Airstrip. A Salva representative (Mr Donaldson) stated that it previously housed an exploration drilling core shed. At the time of the site visit the concrete slab housed a solar powered mobile radio repeater station (Plate 20).

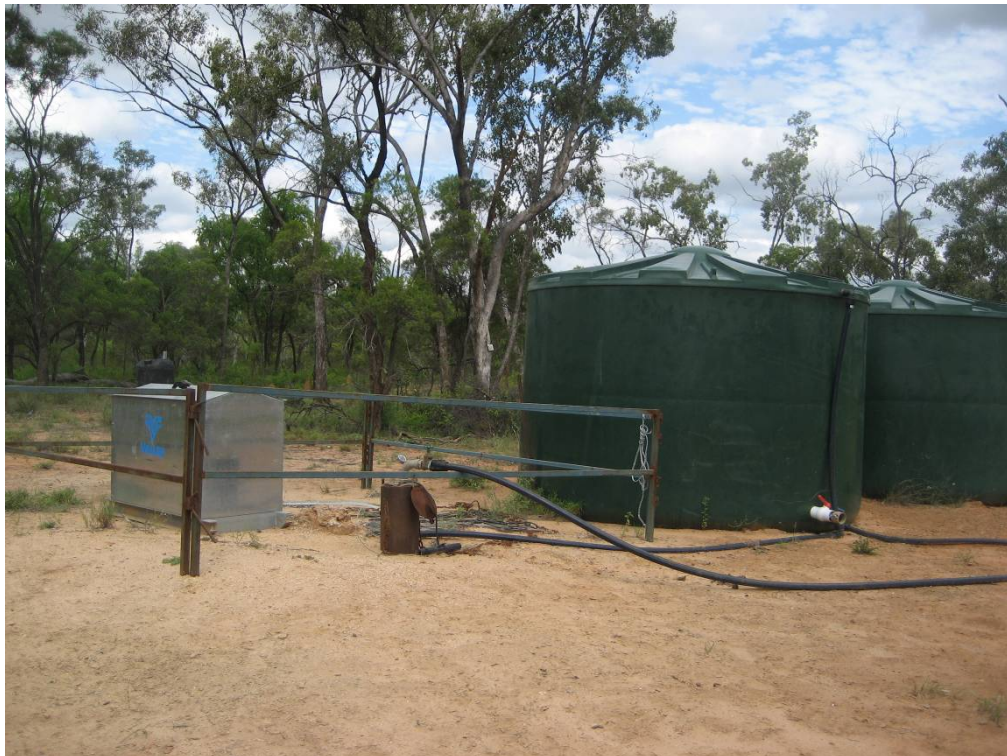
**Plate-21**      **Well Creek / Hancock Bore**

One bore installed by Hancock was identified adjacent to Well Creek (Plate 21). The site was well maintained and minor fuel storage was present. However, no evidence of soil staining or spills was

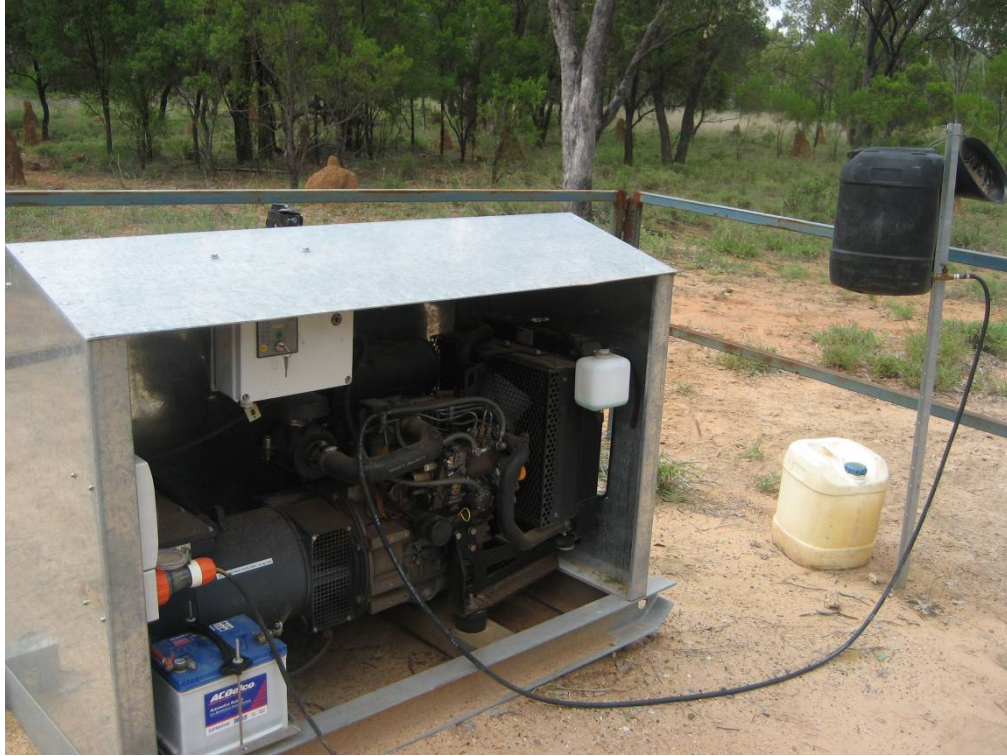
**Plate-22**      **Well Creek / Hancock Bore - water pump**

noted. A Salva representative (Mr Donaldson) informed URS that the pump was only run when required (Plate 22).
